ASB-993

SERVICE BULLETIN

TH-27A/E Low TX Power

May 11, 1992

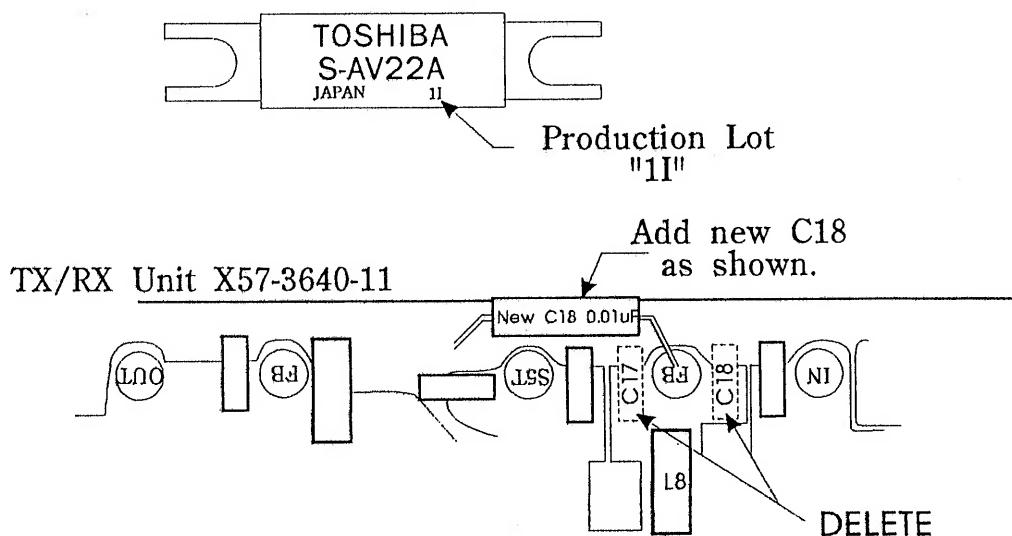
We have noticed some variation in the output power provided by Toshiba S-AV22A power modules with a production code of "11". Modules with this production code might exhibit low or no transmitter output power. This procedure will correct this problem.

Note: Deleting C17 and C18 alone will not correct this symptom. The new C18 will be used to stabilize circuit performance. Deleting C17 alone will not cure the symptom.

1. Remove chip capacitors C17 and C18 from the TX-RX Unit (X57-3640-11.)
2. Install the new axial lead capacitor as shown in the accompanying diagram.
